Case 388 : Narrative

Case Vehicle (A): 1998 Ford	Vehicle (B): 1992 Chrysler
Type: F-150, 4 x 2, 2-door pickup	Type: LeBaron, 2-door coupe
Driver: 73-year-old male	Driver: 56-year-old male
CDC: 12-FYEW-4	CDC: 99-0000-0

CASE NO.: 388-03

CASE VEHICLE: 1998 Ford

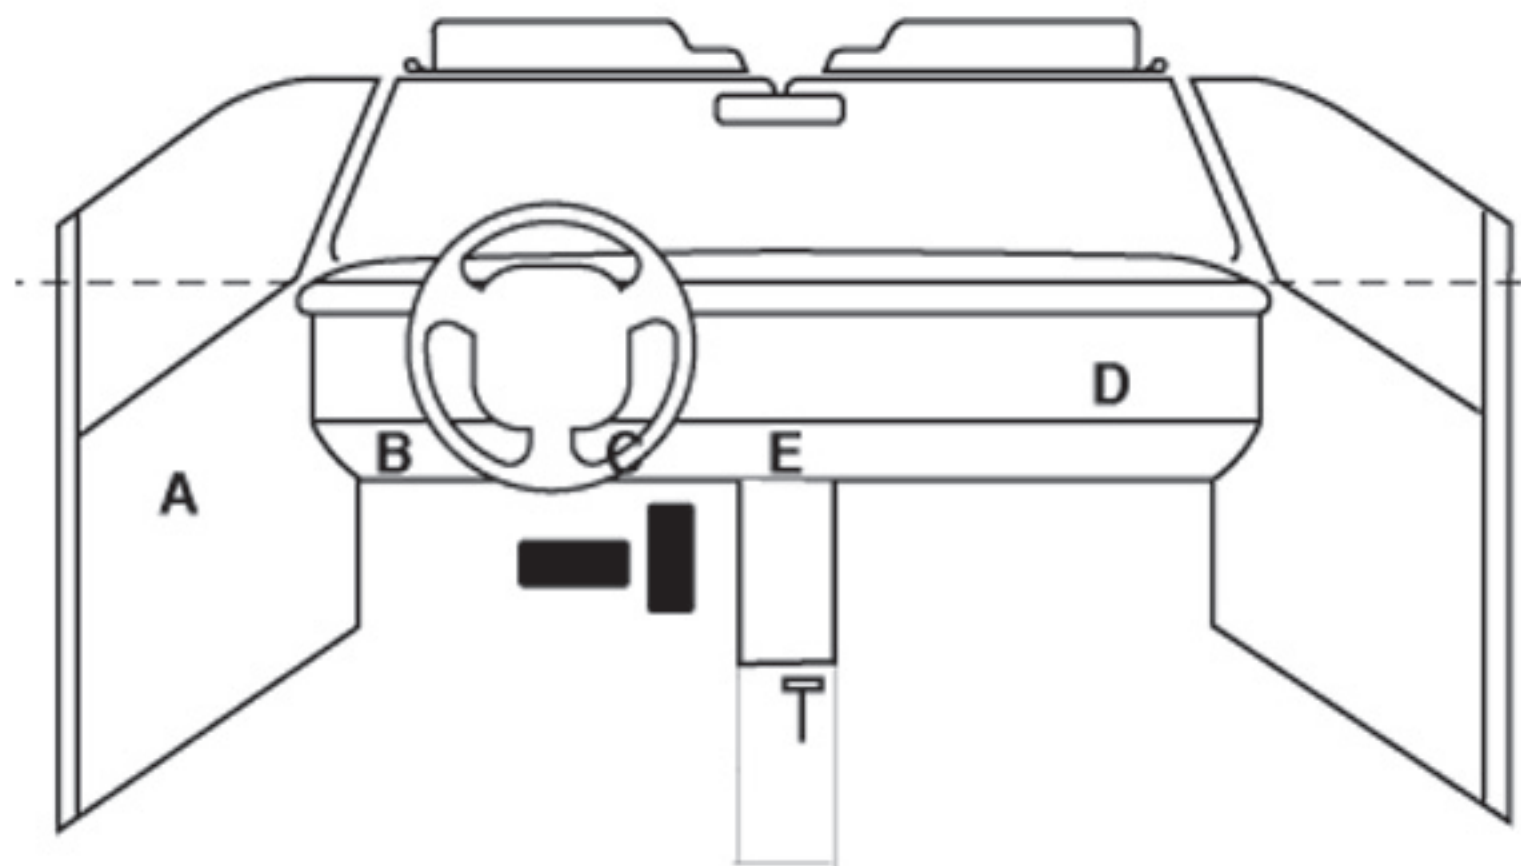
OCCUPANT CONTACT WORKSHEET

- A = driver door, bowed out and plastic broken**
- B = knee bolster - left, indented and plastic broken**
- C = knee bolster - center, scuffmark**
- D = glove box, scuffmark**
- E = ashtray, cloth transfer**
